Wastewater Collection System Rehabilitaion Program Final Report

City of Meridian
Department of Public Works

Wastewater Collection System Rehabilitation Program

**WASTEWATER COLLECTION SYSTEM REHABILITATION PROGRAM
FINAL REPORT**

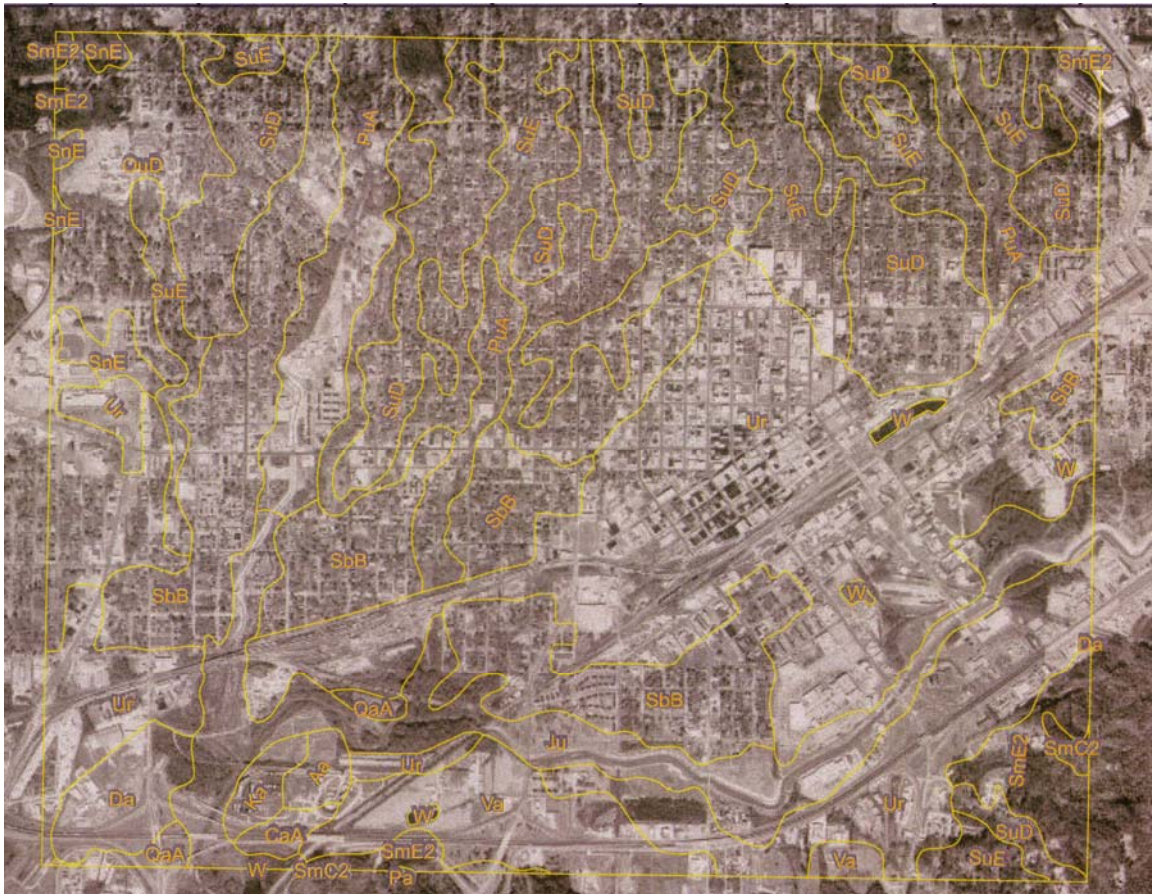
Figure 2
Soils Map

Predominate Soil Associations

- Ur Urban land
- SuE Sweatman-Urban land complex, 5-15% slopes
- SuD Sweatman-Urban land complex, 15-25% slopes
- SbB Savannah-Urban land complex, 0-5% slopes

Located in extreme east central Mississippi (Figure 1), the Meridian collection system consists of approximately 303 miles of gravity sewer with a replacement value of \$240 million. The soils are predominately Urban land and Sweatman-Urban land complex, 5 to 25 percent slopes. Figure 2 shows the major soil associations within Meridian. Rapid storm runoff will lessen the time that system defects are exposed or inundated with storm water. Normal annual rainfall is 56.71 inches (Figure 3).

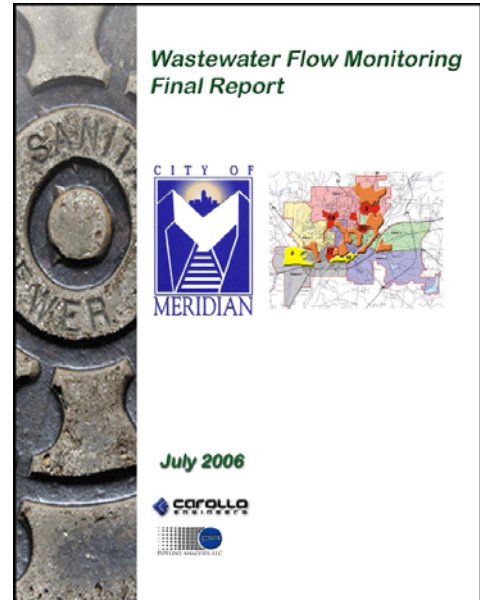
Figure 6
Priority Ranking of Basins

Flow monitoring is used to establish the areas of the collection system that contribute to excessive rainfall dependent infiltration/inflow (RDII). The City has completed a flow monitoring study in which thirty portable flow meters were placed within the system to trace excessive infiltration/inflow and prioritize additional field efforts. Results of this flow monitoring was presented in a July 2006 "Wastewater Flow Monitoring Final Report". The data presented in the report was used to prioritize areas of the collection system for subsequent inspections. Figure 6 presents the priority ranking of areas based on the severity of infiltration/inflow.
